# Building and Rebuilding with earth

## Earthen architecture in Cyprus; the problem of conservation

Diomedes Myrianthefs

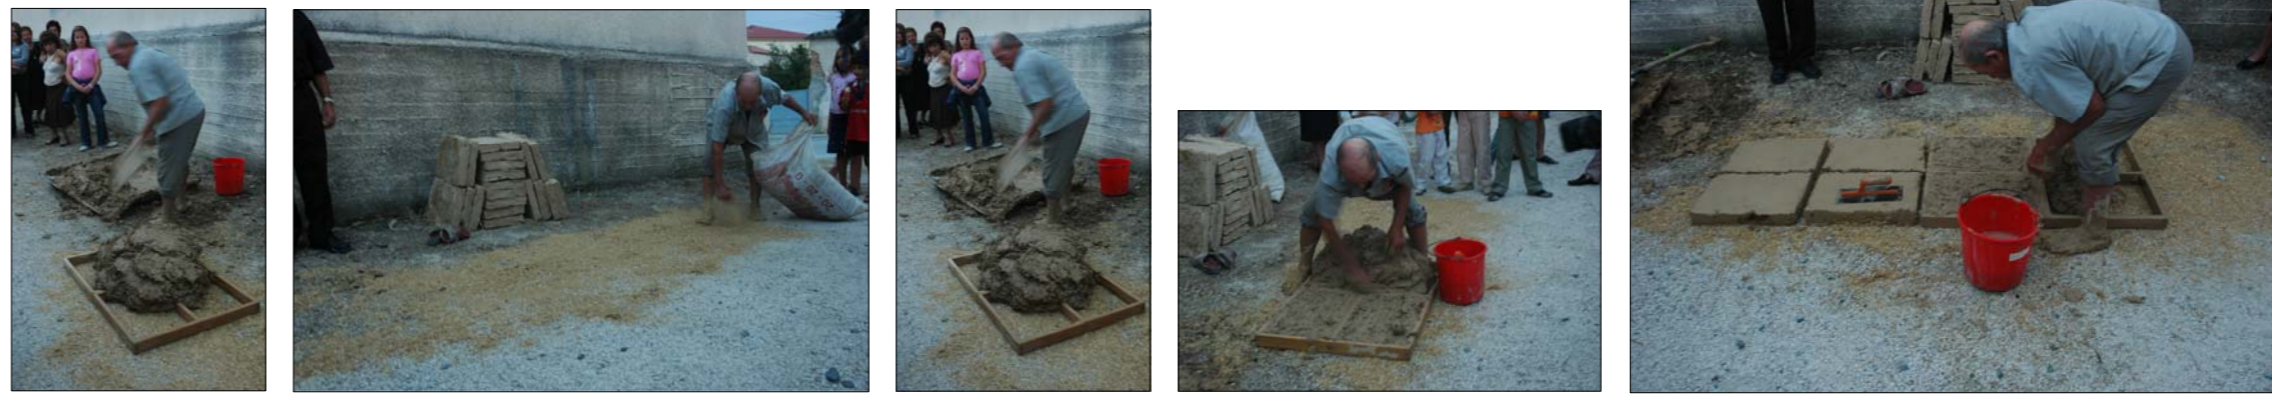
Mud brick construction

Adobe architecture has been mainly used in the plains where soil is plentiful and stone rare and difficult to obtain. Mud bricks were made with the use of local soil and the addition of binders such chaff, straw and ear as the most common ones. Also goat hair and seaweed was used depending on the location and availability. The mixture of soil, straw and water was left for few hours up to a day so as cellulose was released to give adhesive properties and make it mouldable. Mud bricks were prepared with the use of a wooden mould of internal dimensions 30x45x5 cm and were left to dry for at least a week. Mud bricks were only made during the summer.

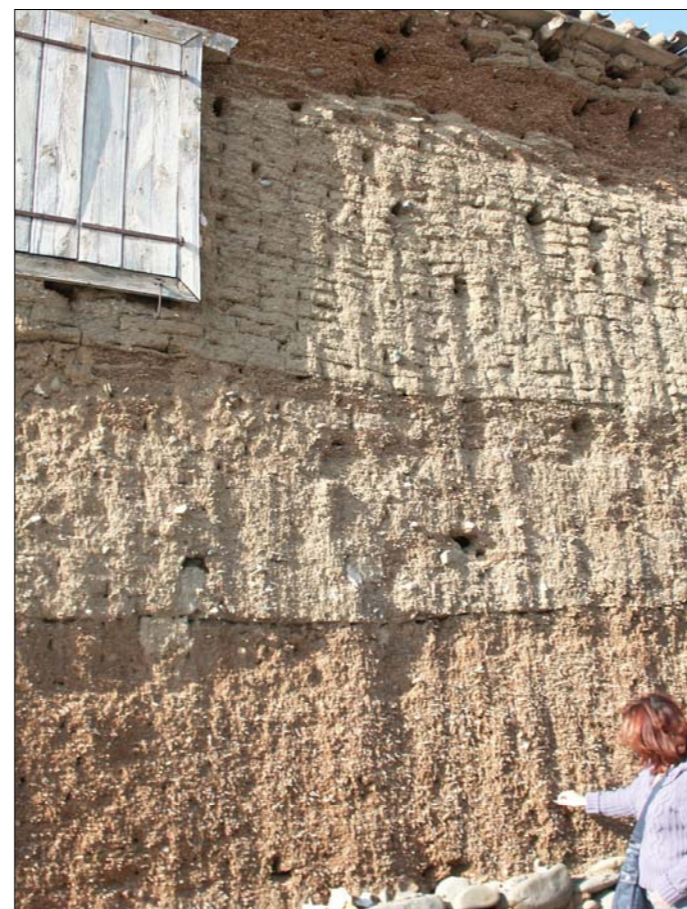
Plan of typical mud brick house

The basic rural dwelling in Cyprus is the single-unit structure. Two can be considered the main types of this. In the plains and in the settlements of the foothills of the mountains the type that prevails is the broad-front single-room house (*makrinari*). The maximum width of the *makrinari* varies from 3-4 meters which is determined by the constructional properties of the timber available where the length of the building varies between 6-8 meters or even more. A second basic type of a single-unit house is that in which the almost rectangular room (*palati* or *dichoro*) is divided either by a large, often pointed, arch that supports the roof or by a wooden post on which the central beam rests and carries either a pitched roof or an almost flat roof. In these cases and according to the timber available the dimensions are about 6X6 meters. Of course the variety of the islands rural houses is not limited to the above mentioned basic types. There are many house variations as a result of either successive extensions or additions of auxiliary units to the basic one. According to the plot and the area available a house was built and extended as a single-storey building (plains) or in two levels (mountainous regions). In the towns the typology differs, especially from the end of 19th century onwards, as neo-classical characteristics were incorporated both in typology and façade formation. In this category a central common room (*ilakos*) is surrounded on both sides by rectangular rooms which with the backyard additions, the verantahs etc create a more complex type of dwelling.

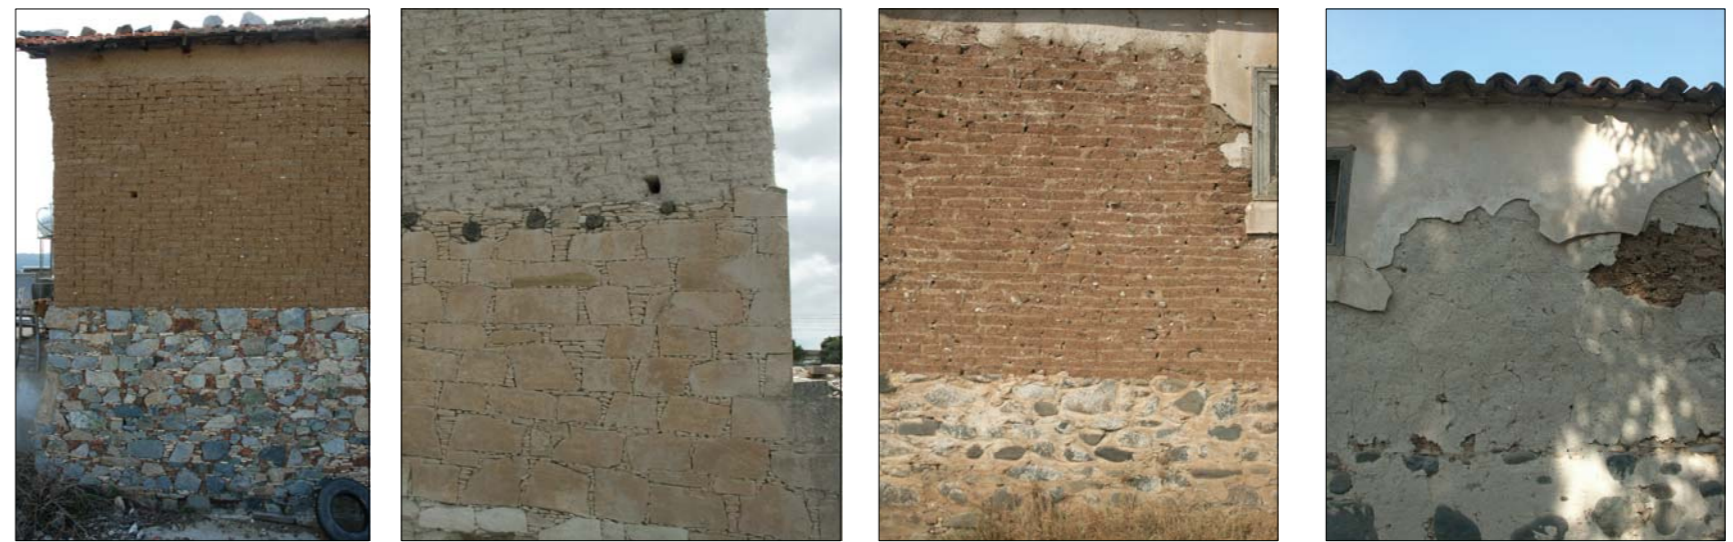
Different types of walls and mud bricks

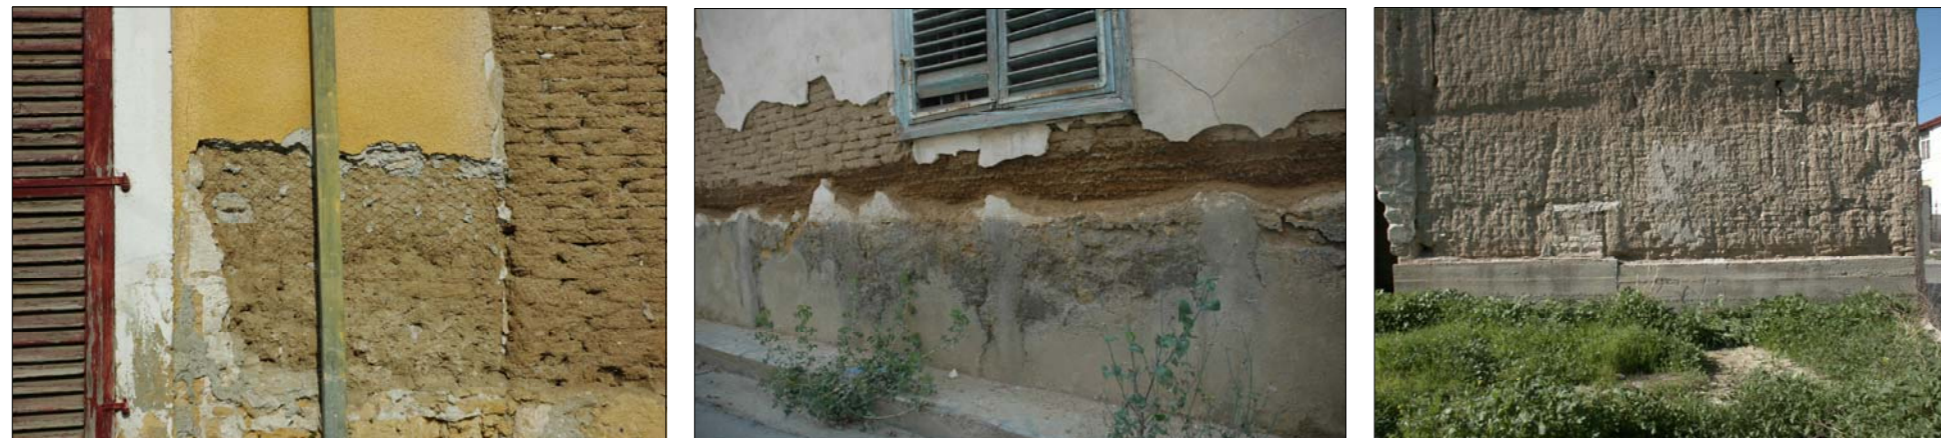
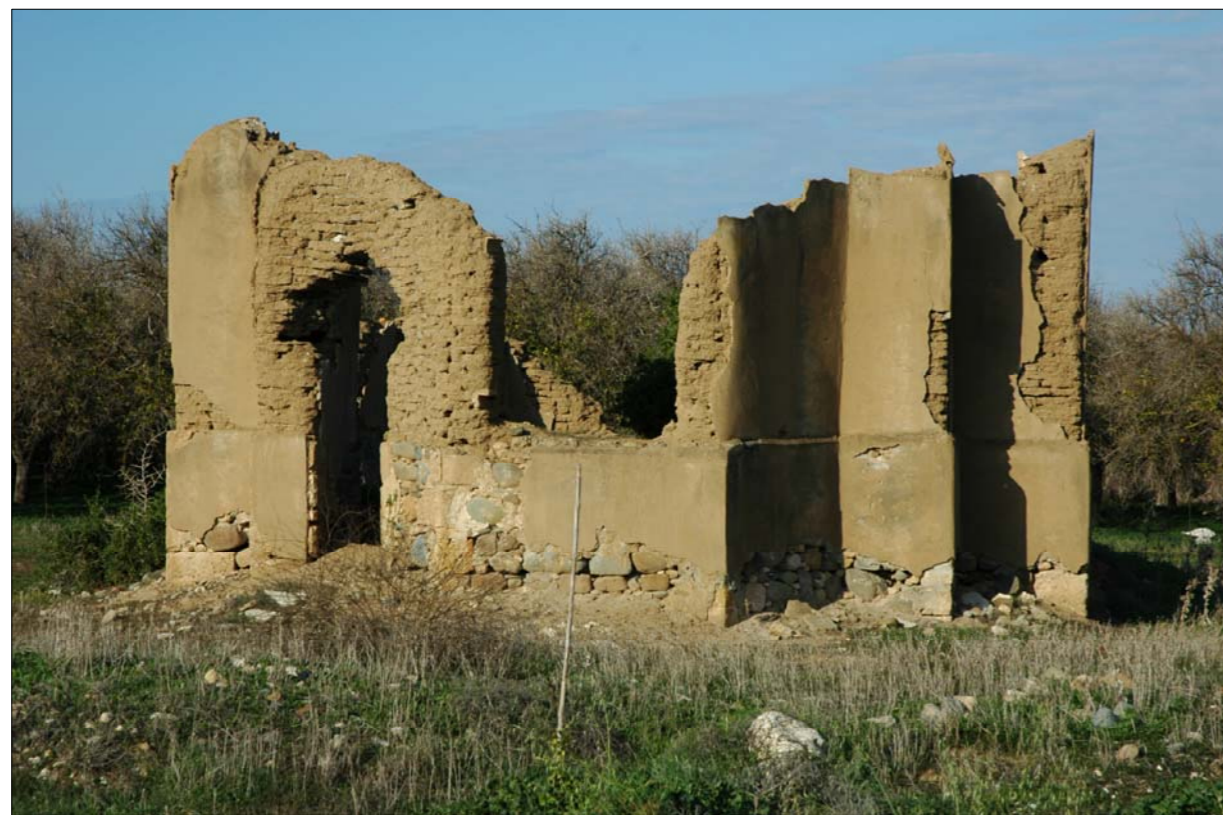
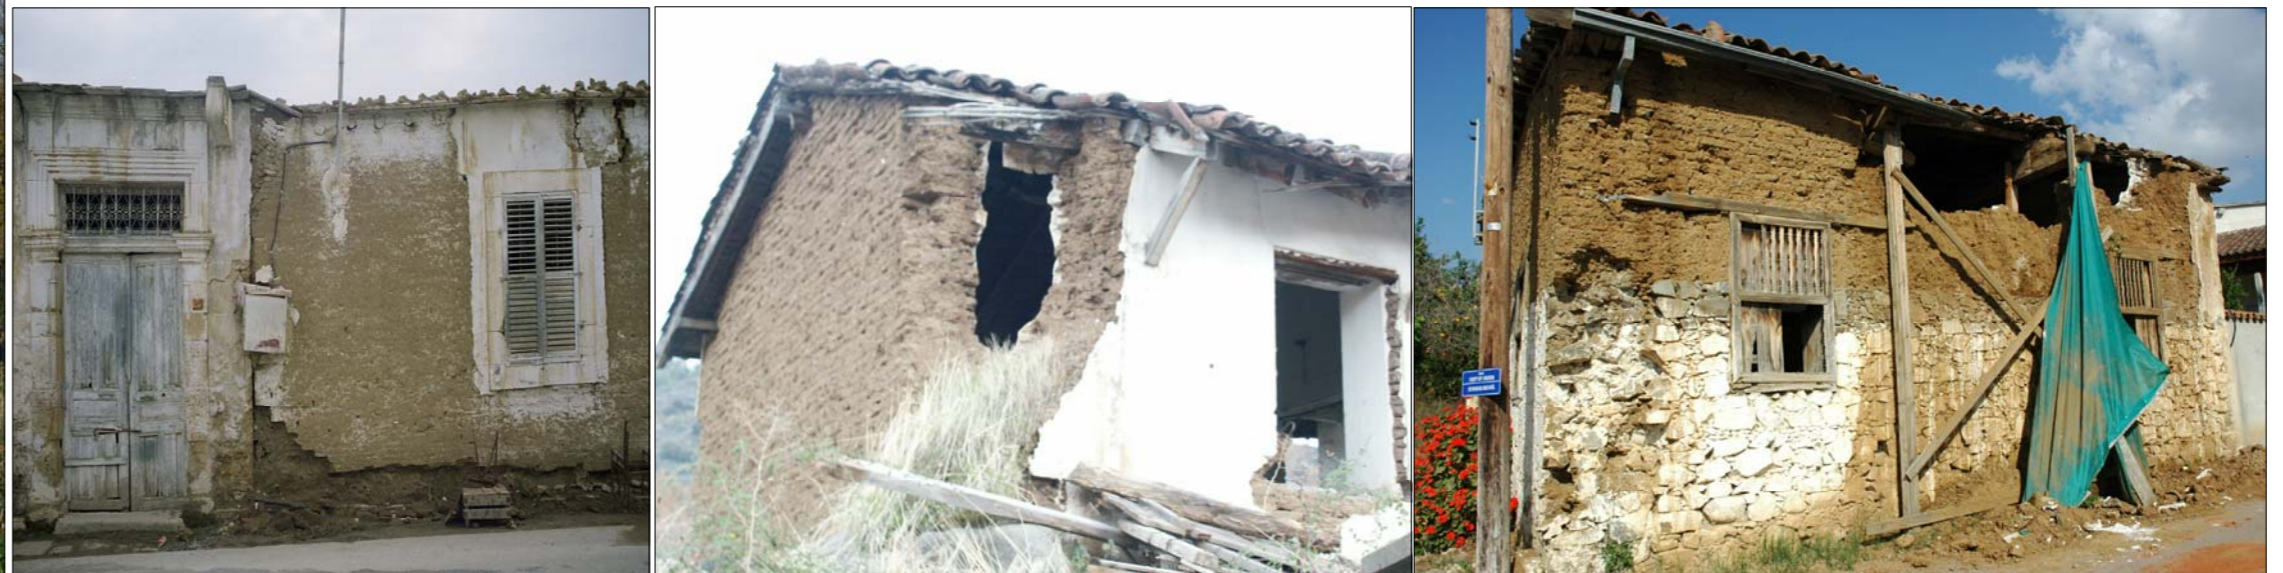
C  
A  
U  
S  
E  
S  
O  
F  
D  
E  
C  
A  
Y

1. Deterioration at the base of the wall. The rising damp penetrates into the mass of the wall and depending on the temperature alterations it is drawn outwards. Thus the evaporating water leaves behind crystalline salts breaking this way the coherence of the soil and creates disintegration of the material which is then easily eroded by wind action. The process continues upwards and inwards, undercutting the wall structure and it may end to a collapse.

2. Deterioration at the top of the wall. Water penetrates when the roof structure at the top of the wall fails. Hair cracks due to excessive wetting gradually develop to channels which become thinner and die out as they progress downwards. This procedure leads to extensive disintegration of the bricks and to vertical cracking.

3. Disintegration of the material. Damp penetrated the wall gradually evaporates and through the freezing-thawing cycle causes loss of the material cohesion which is pulverised and becomes dust.

4. Cracking is developed as a result of structural inefficiency due to extrinsic causes like earthquake or due to poor foundation construction which causes displacements and bending.

5. Human activity. In order to "strengthen" or "protect" the sensitive mud brick material or its stone base from external dump and water, cement plaster was extensively applied. This method proved to be catastrophic for the mud wall as the cement render being stronger than the earthen core does not allow humidity to be released and leads to humidity accumulation in the core of the wall. This leads eventually to the extensive disintegration of the mud brick.

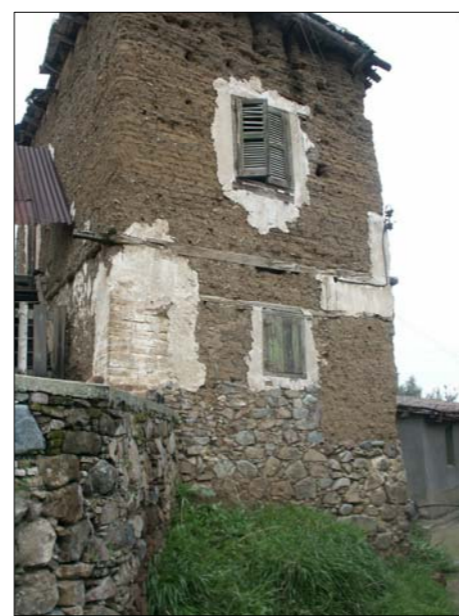
Before repair

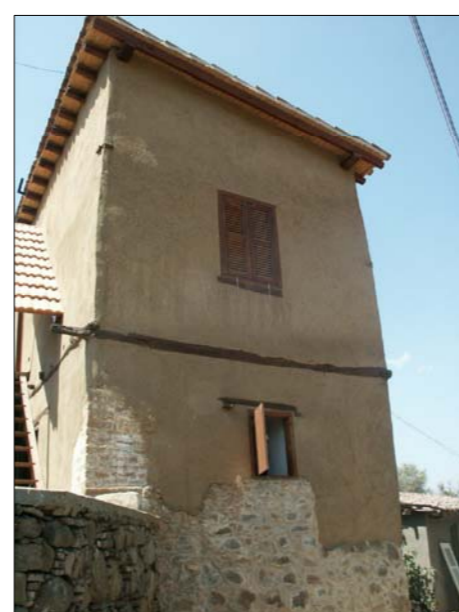
After repair

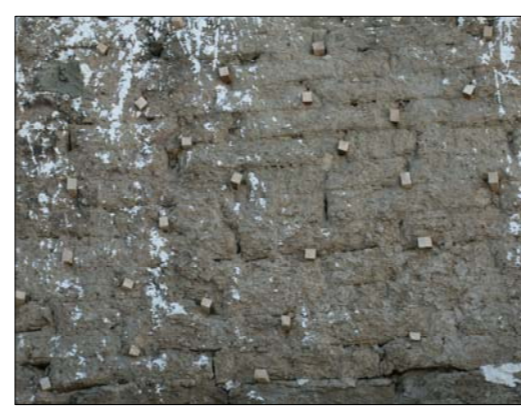
Wooden pegs to receive new plaster

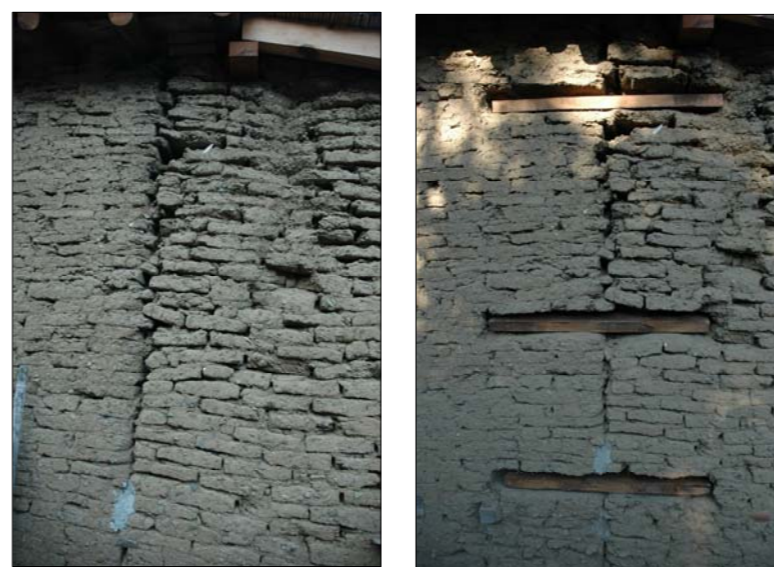
Insertion of wooden beams to "tie" and strengthen mud brick walls

2. Repairs in the body of the wall. Heavily damaged mud bricks should always be replaced. Precaution must be taken in relation with the "soil compatibility" and the proper bonding of the new with the existing. Replacements of mud bricks with other material than that (fired bricks etc) should be avoided as incompatibility may result to poor connection. If the damaged part is a corner or is accompanied by cracks a further strengthening method must be applied. The most common one is the insertion of a wooden tie beam at an appropriate length and at several levels along the height of the wall (stitching). If it is necessary wooden tie beams could be inserted on both sides of the wall and should be, in this case, properly connected between them. The same way a proper interlocking of the corners must be inserted if the existing one is not appropriate or does not exist at all. It is of crucial importance to create a proper tie at the top of the wall to establish the diaphragm function. This can be done by the insertion of ring beam(s) where the wood structure of the roof/floor can rest.

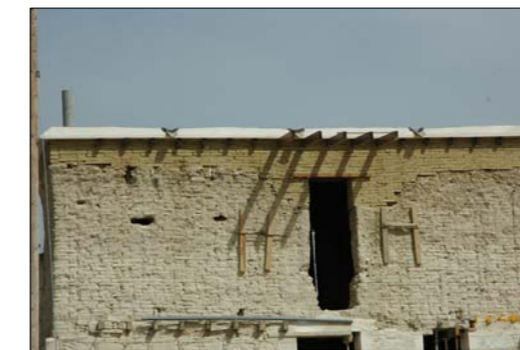
Completion of missing upper part of the wall with new adobe

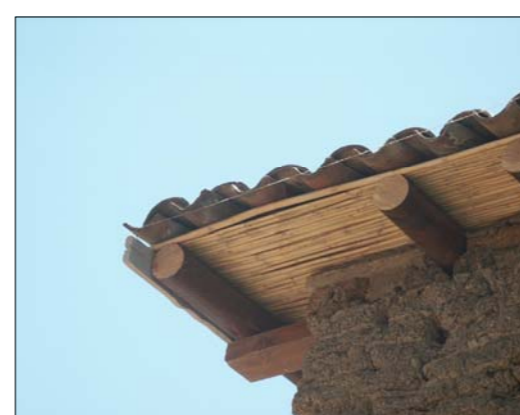
Construction of new roof (with tiles & cane) on a mud brick wall

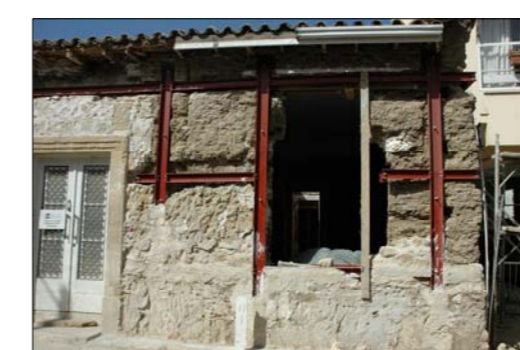
New metallic structure inserted into mud brick wall

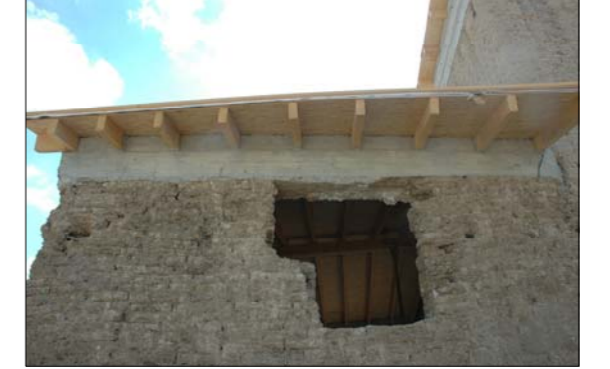
Non compatible concrete beam

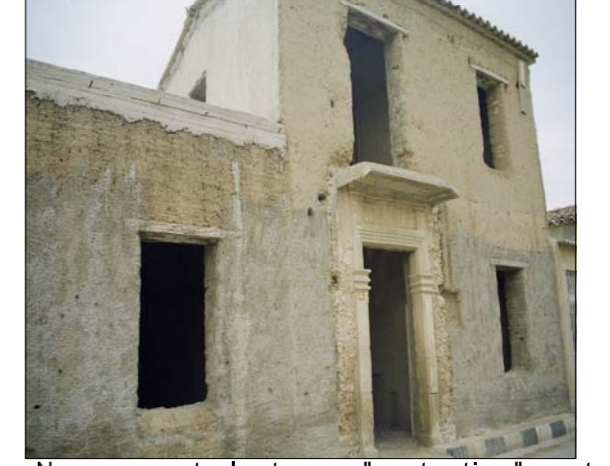
New cement plaster as "protective" coat

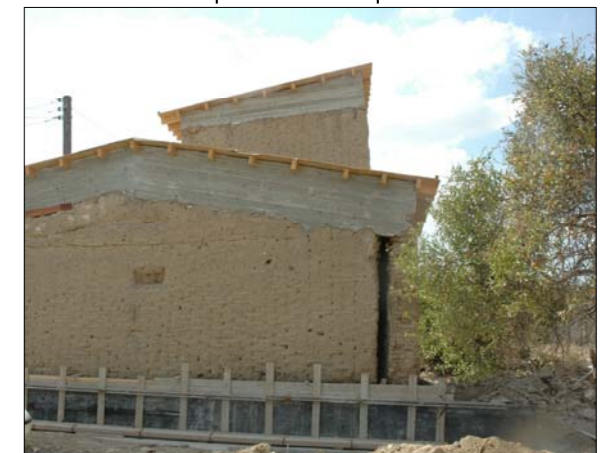
Incompatible concrete beams to support the roof & strengthen the foundation
